## **Assessment of Dam Safety of Coal Combustion Surface Impoundments**

**Indianapolis Power & Light Company**

**Harding Street Generating Station**

**June 4, 2010**

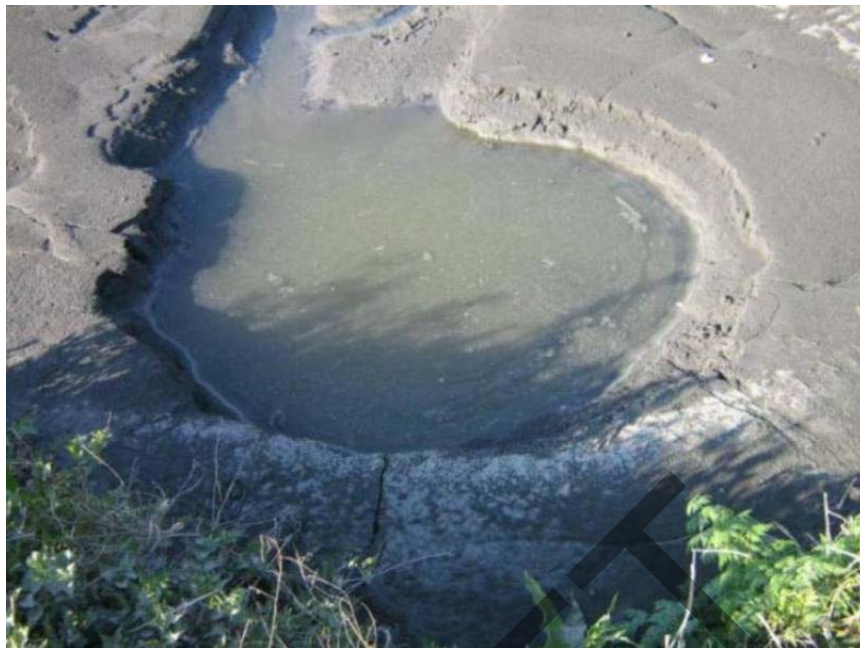
107. Ash Pond 4 - Submerged Inlet from Ash Pond 4A

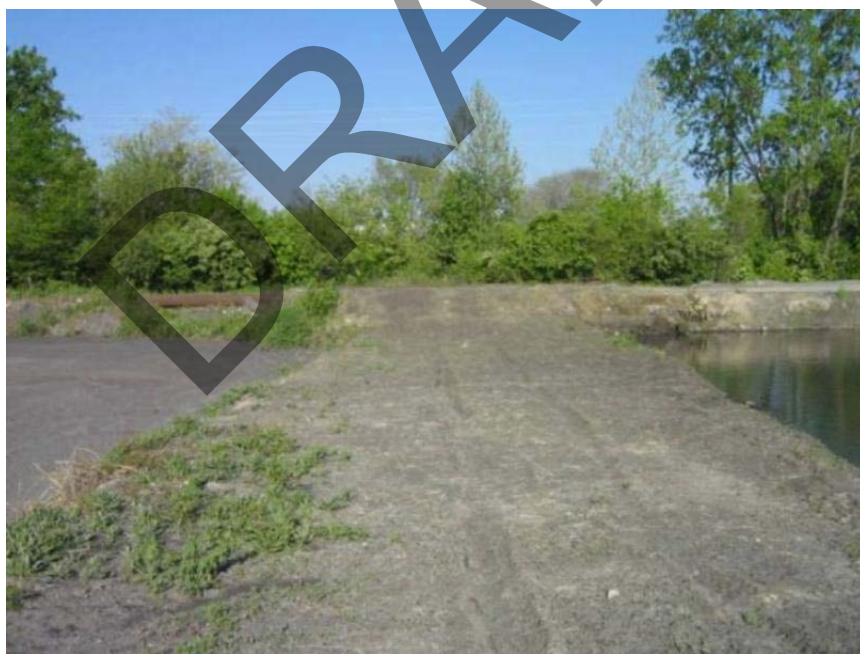
108. Ash Pond 4 - North Embankment Crest, Looking West

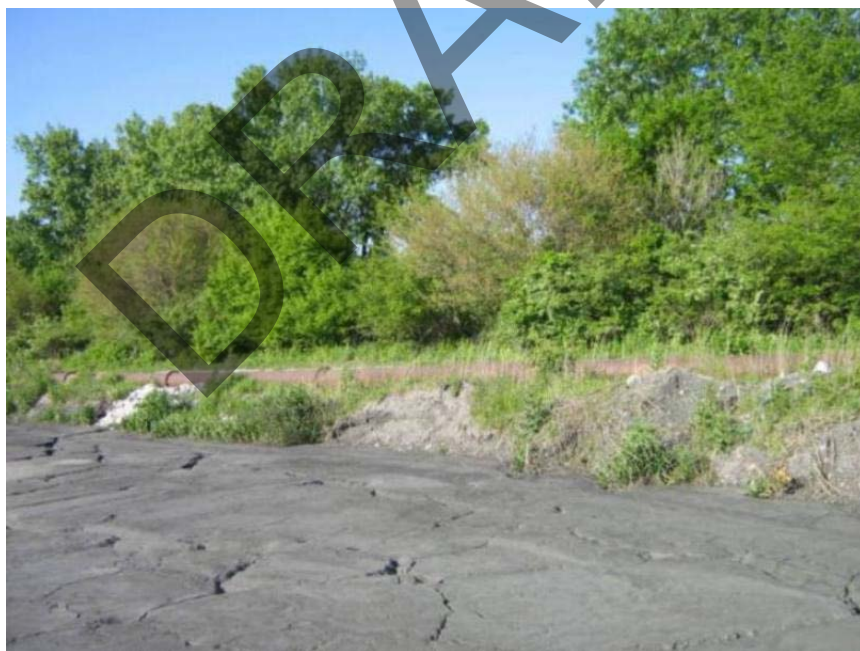
110. Ash Pond 4 - West Embankment Interior Slope, View from Pond

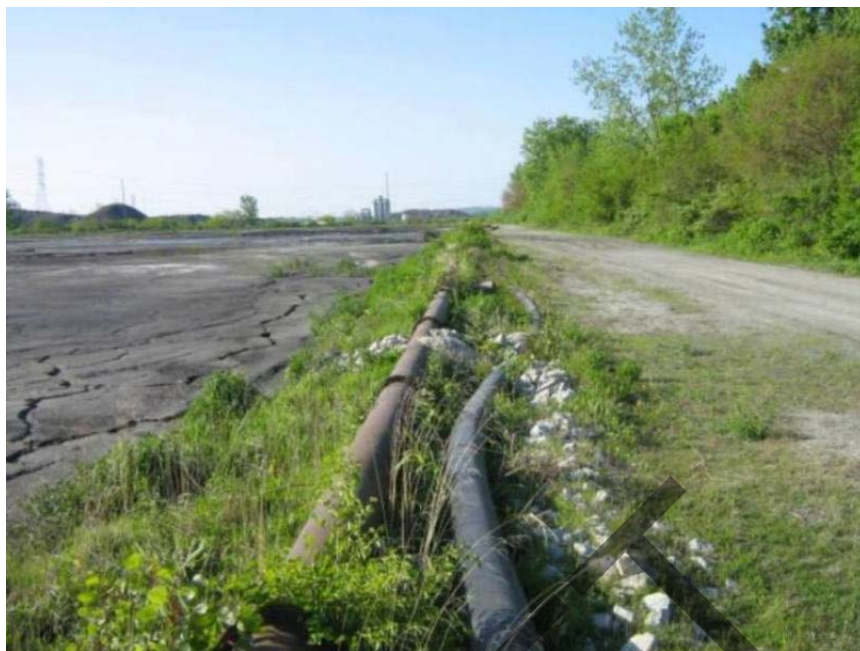
111. Ash Pond 4 - Sluice Lines Located along West Embankment Interior Slope, Looking South

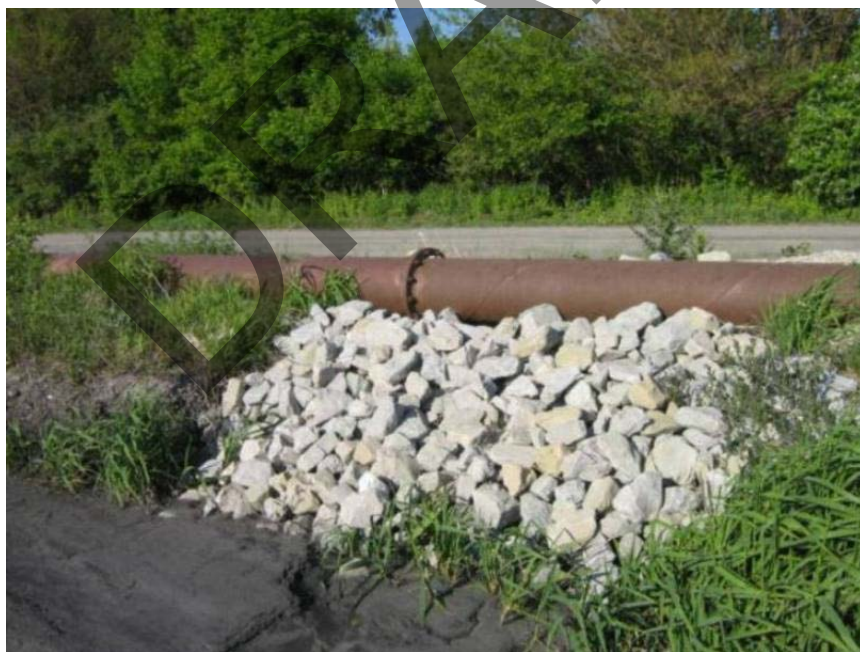
112. Ash Pond 4 - West Embankment Interior Slope, Riprap under Sluice Line to Address Undercut

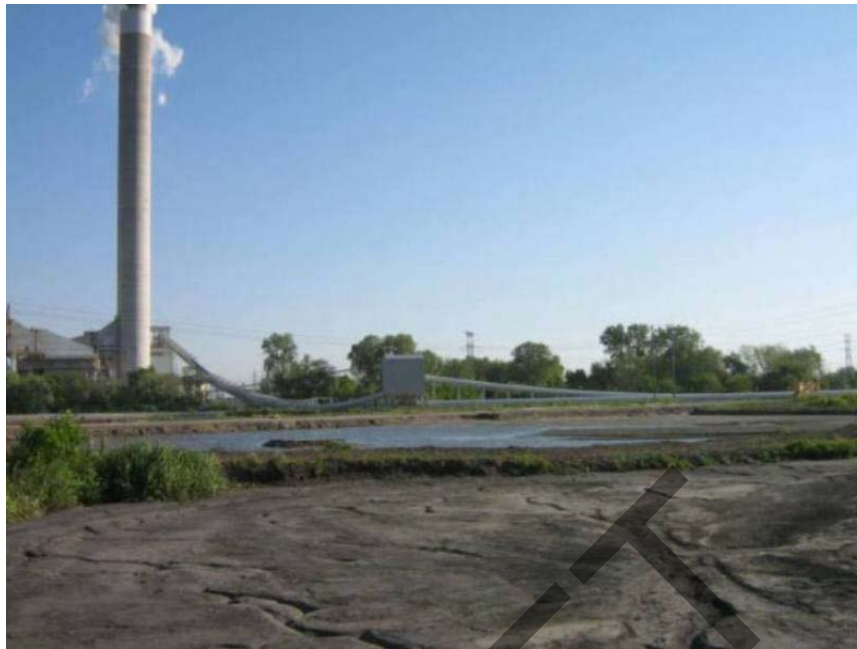
113. Ash Pond 4 - Freeboard along North Embankment Interior Slope

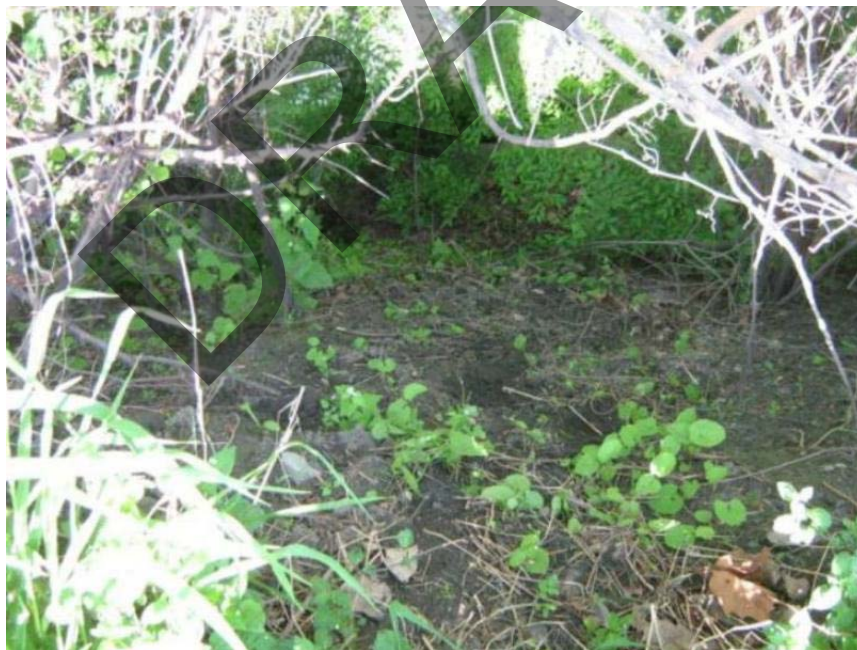
114. Ash Pond 4 - West Embankment Interior Slope, Looking West

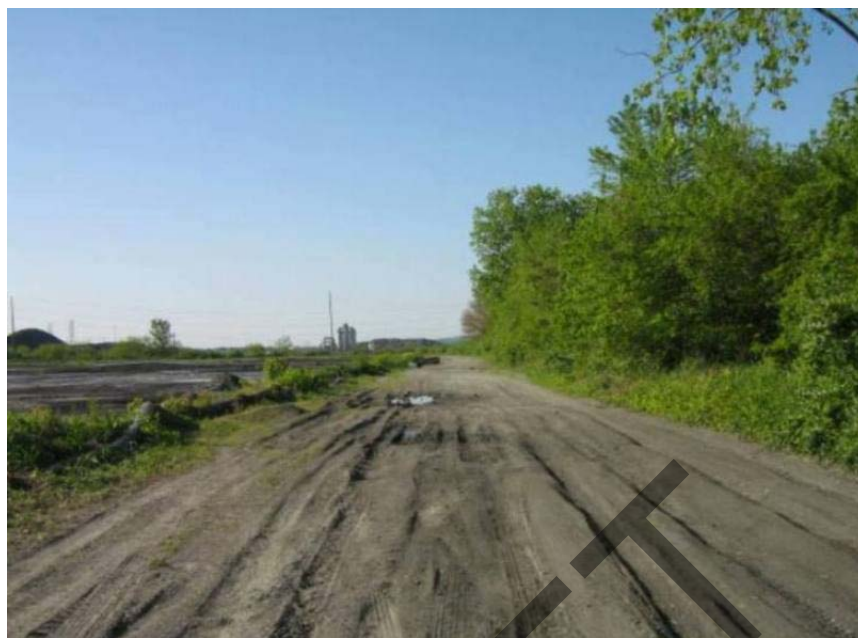
115. Ash Pond 4 - West Embankment Crest, Looking South,  
Showing Ruts along Crest

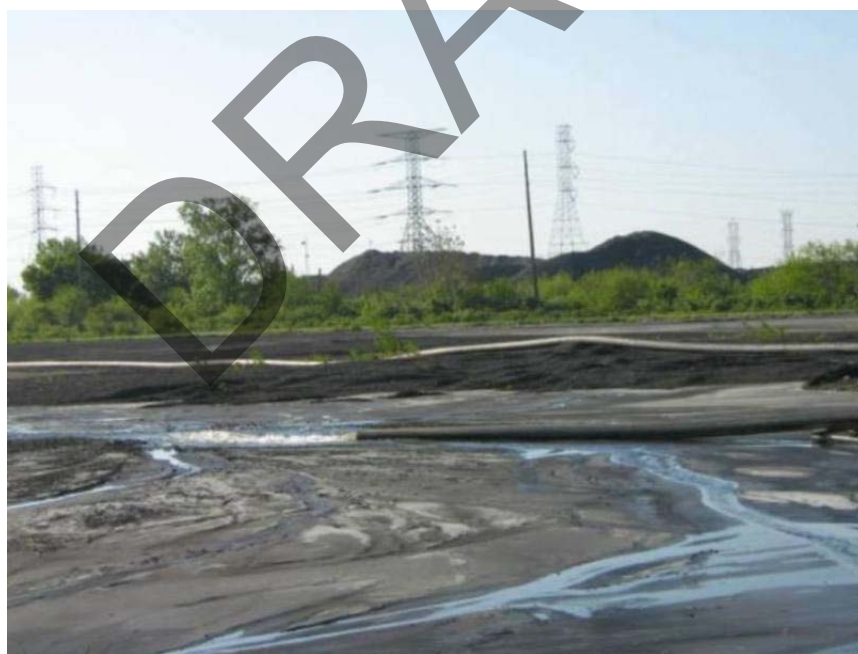
116. Ash Pond 4 - Discharge into Pond along West Embankment  
Crest

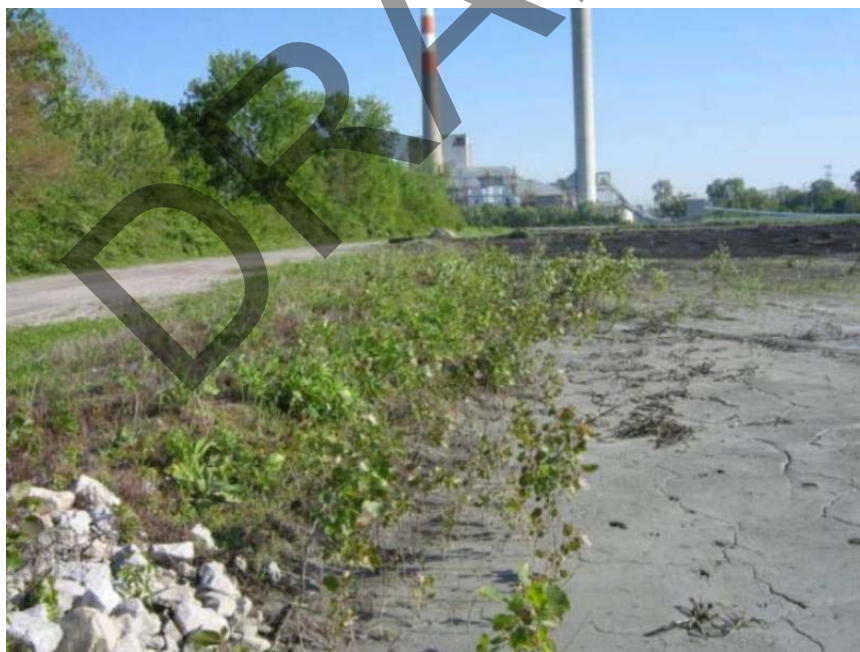
120. Ash Pond 4 - Vegetation along West Embankment Interior Slope, Looking North

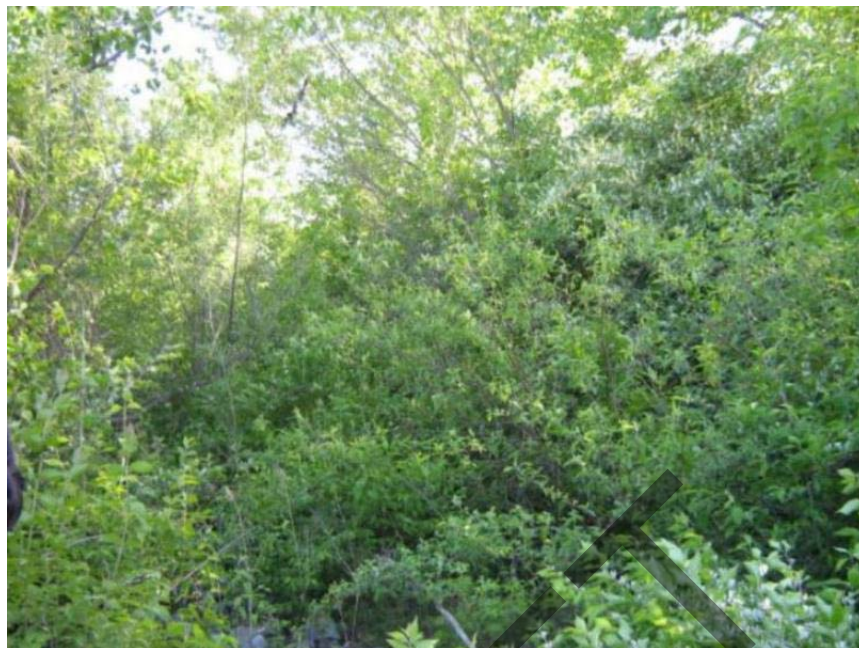
121. Ash Pond 4 - West Embankment Exterior Slope, Heavy Vegetation on Slope

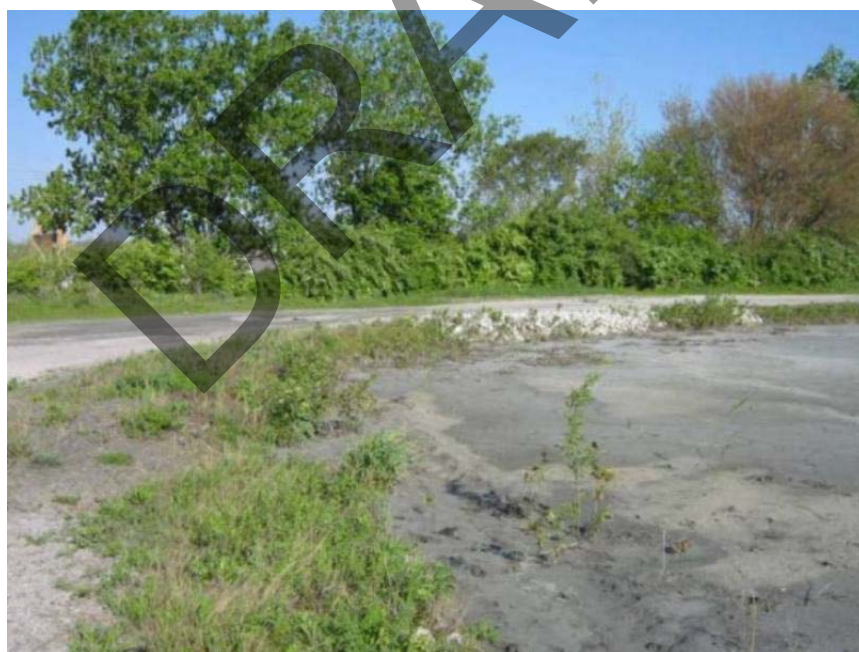
122. Ash Pond 4 - West Embankment Interior Slope, Looking West

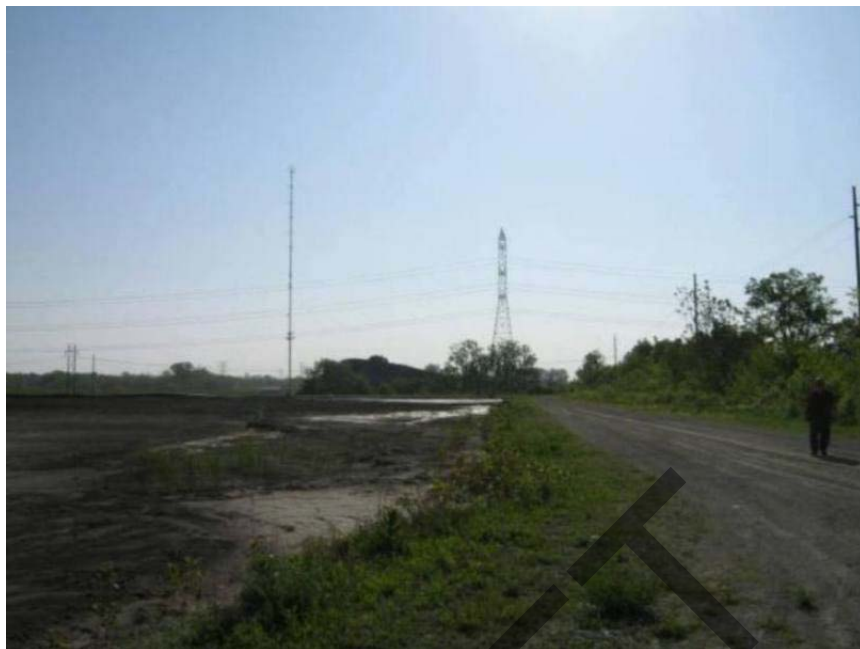
123. Ash Pond 4 - South Embankment Crest and Interior Slope, Looking East

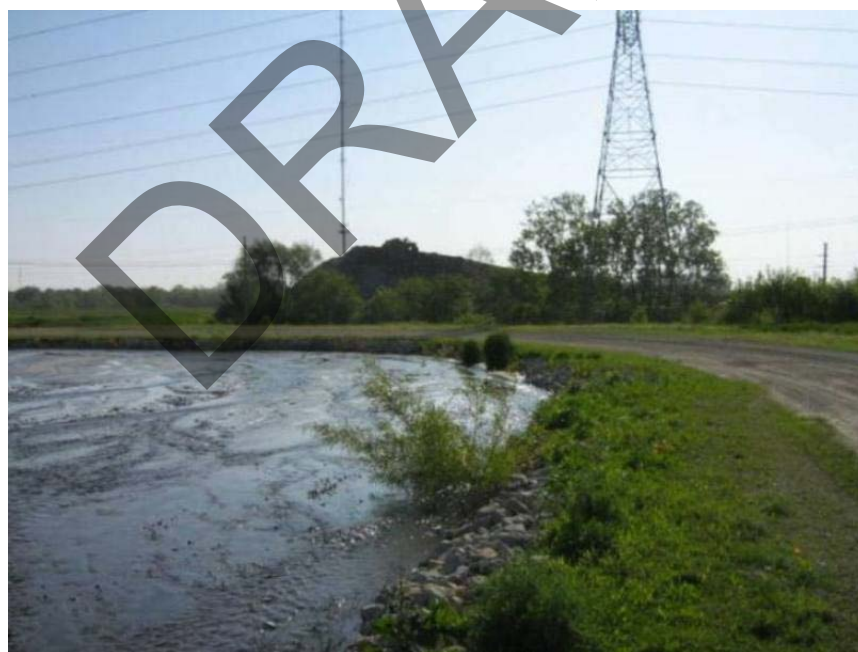
126. Ash Pond 4 - Southeastern Embankment Interior Slope,  
Looking East

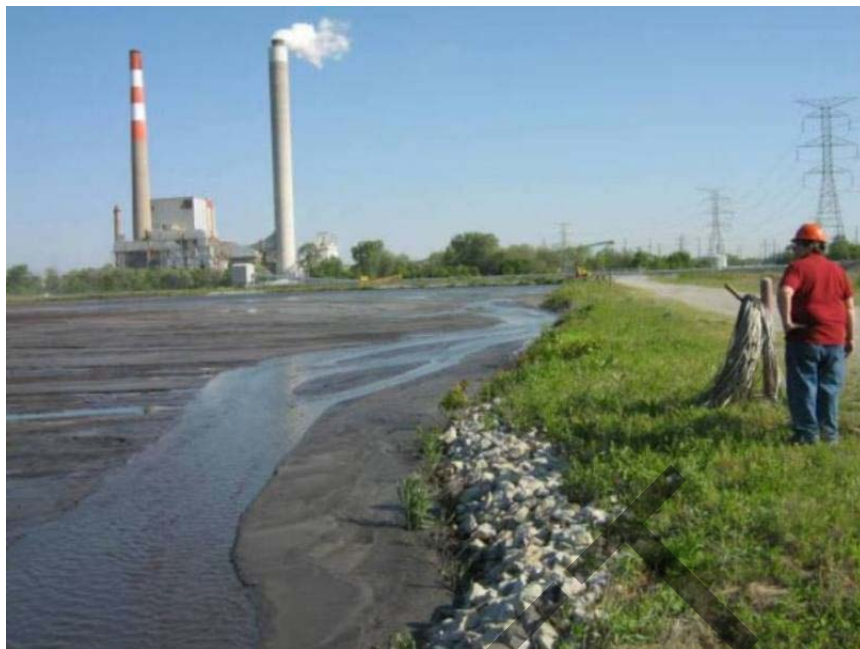
127. Ash Pond 4 - East Embankment Interior Slope, Looking North

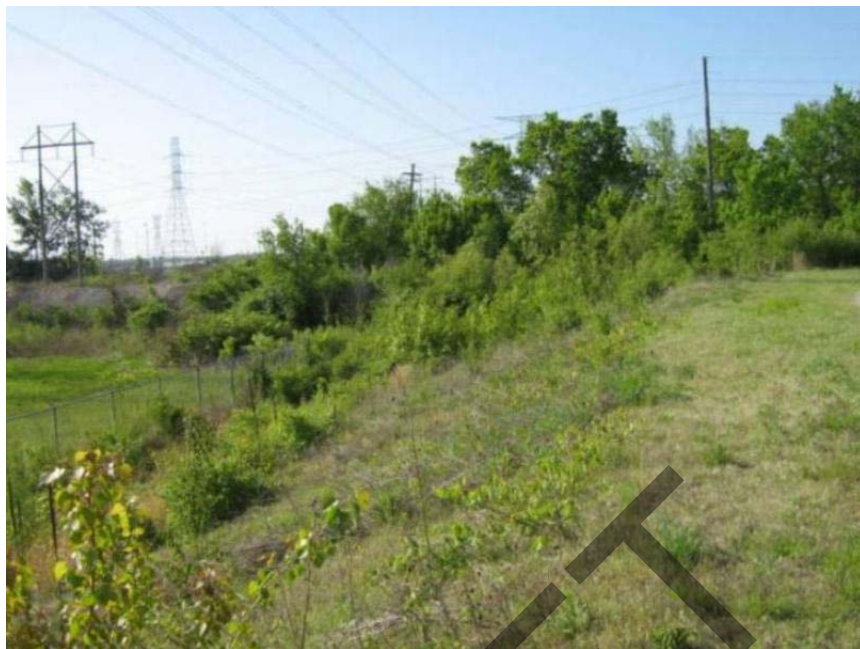
129. Ash Pond 4 - East Embankment Exterior Slope, Looking South

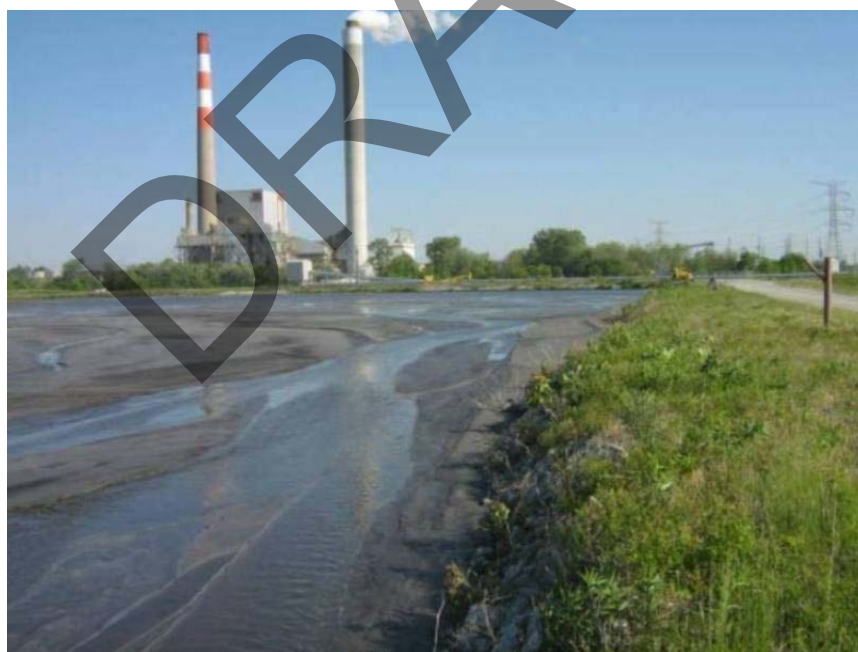
132. Ash Pond 4 - East Embankment Interior Slope, Looking North

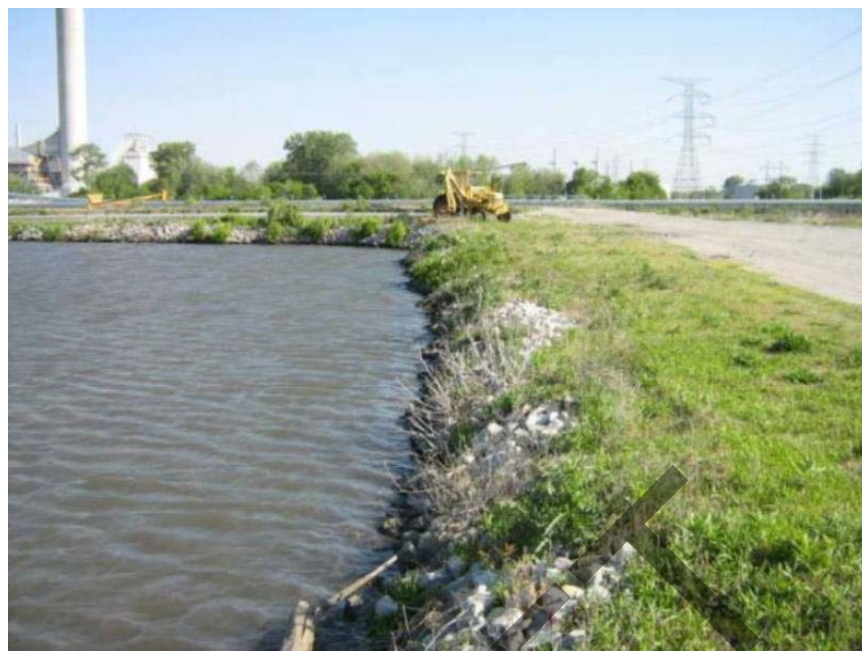
133. Ash Pond 4 - East Embankment Interior Slope, Looking North,  
Riprap lines the Interior Embankment

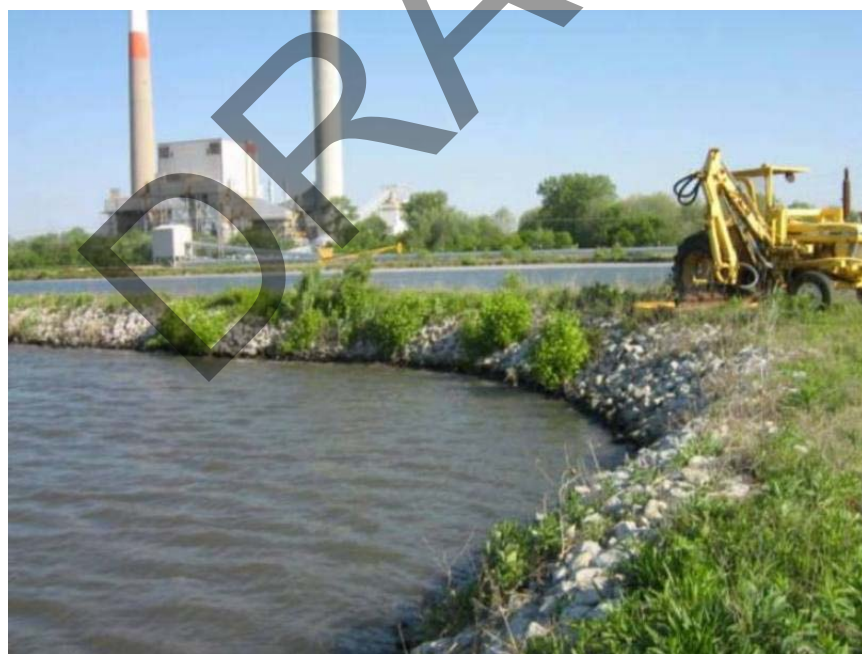
134. Ash Pond 4 - Northeastern Embankment Interior Slope,  
Looking North, Riprap lines the Interior Embankment

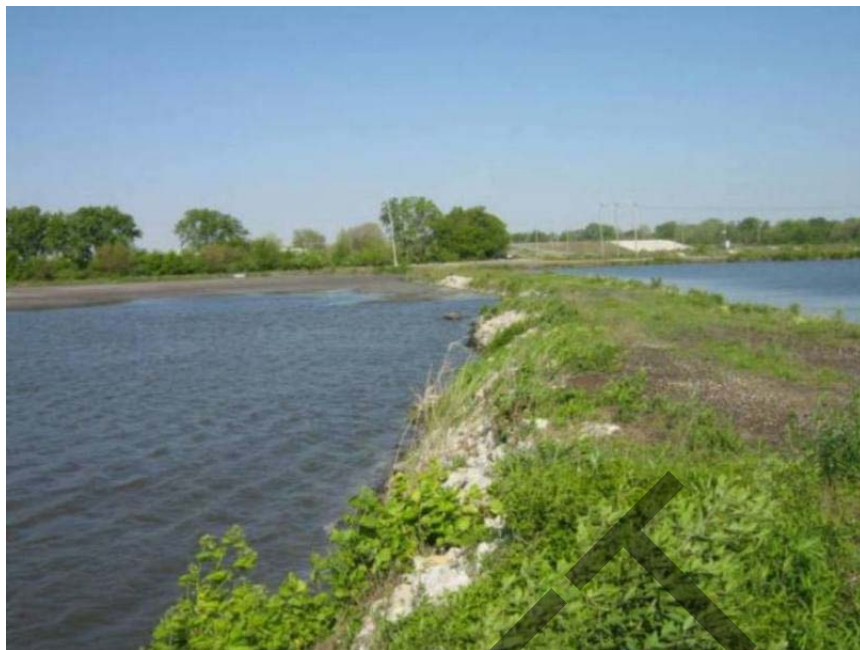
135. Ash Pond 4 - North Embankment Interior Slope, Looking West,  
Vegetation is Present

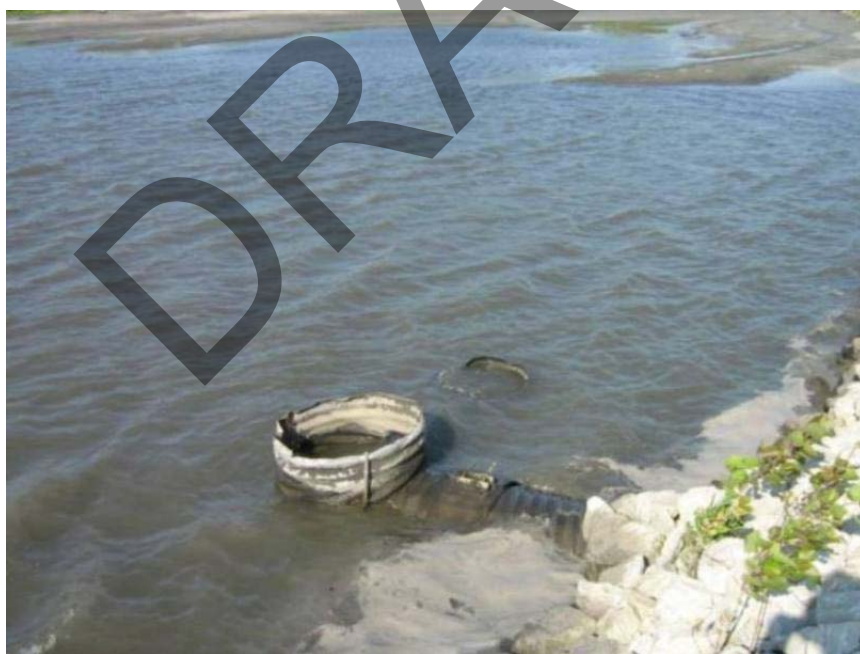
136. Ash Pond 4 - Two (2) 30-inch-Diameter CMP Outlets to Ash  
Pond 4B

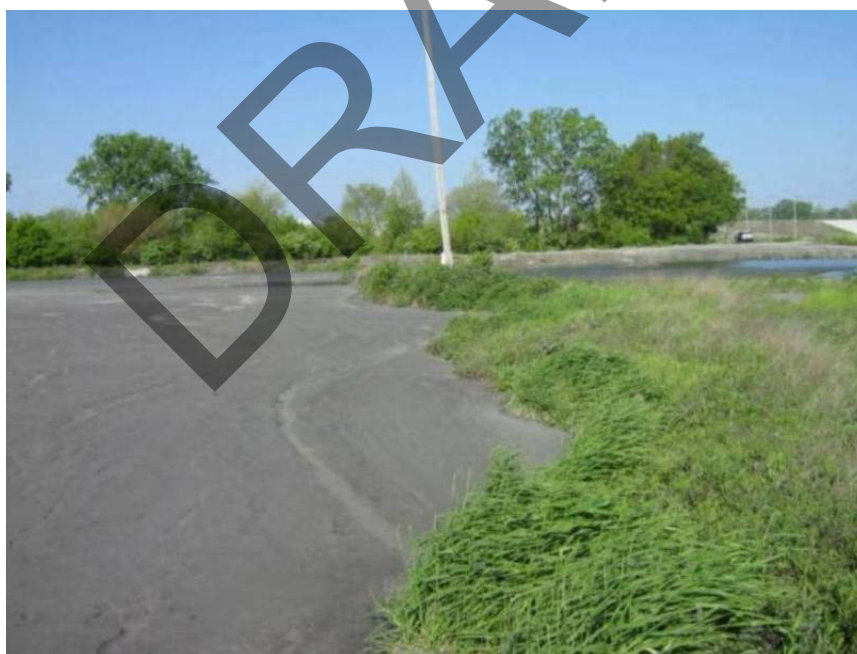
138. Ash Pond 4 - North Embankment Interior Slope, Looking West

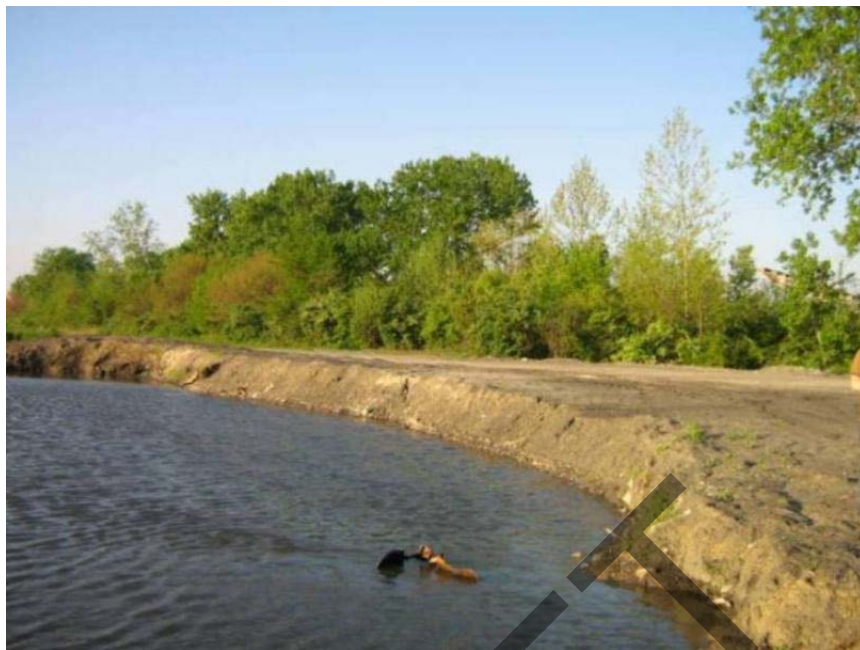
139. Ash Pond 4A - North Embankment Interior Slope, Looking West

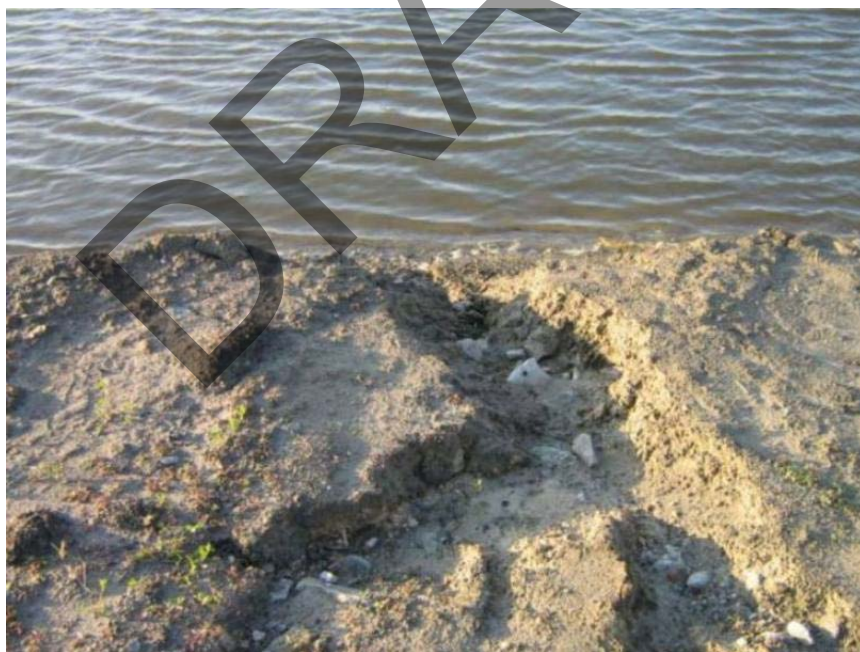
140. Ash Pond 4A - Erosion Rill on North Embankment Interior Slope

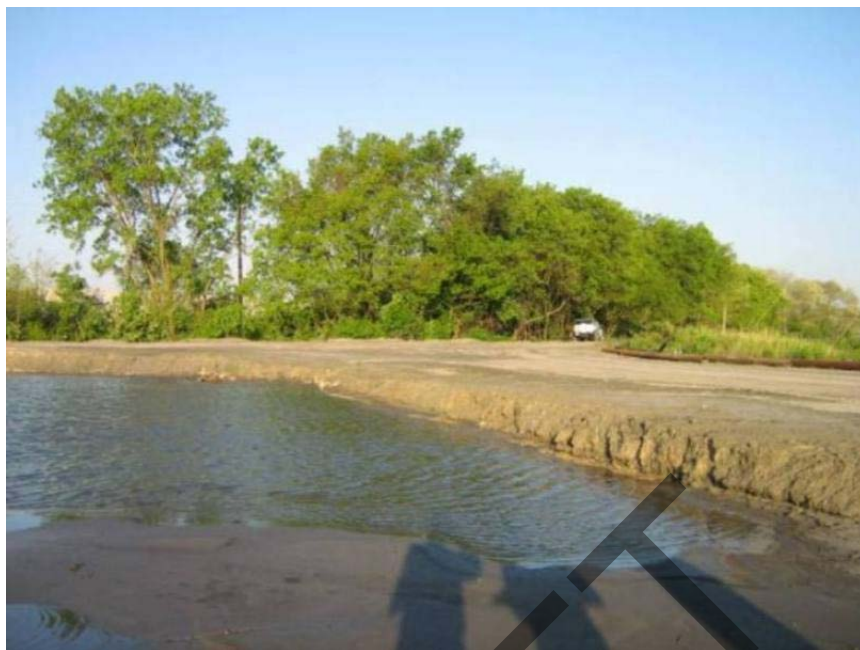
141. Ash Pond 4A - North Embankment Interior Slope, Looking Southwest from Pond

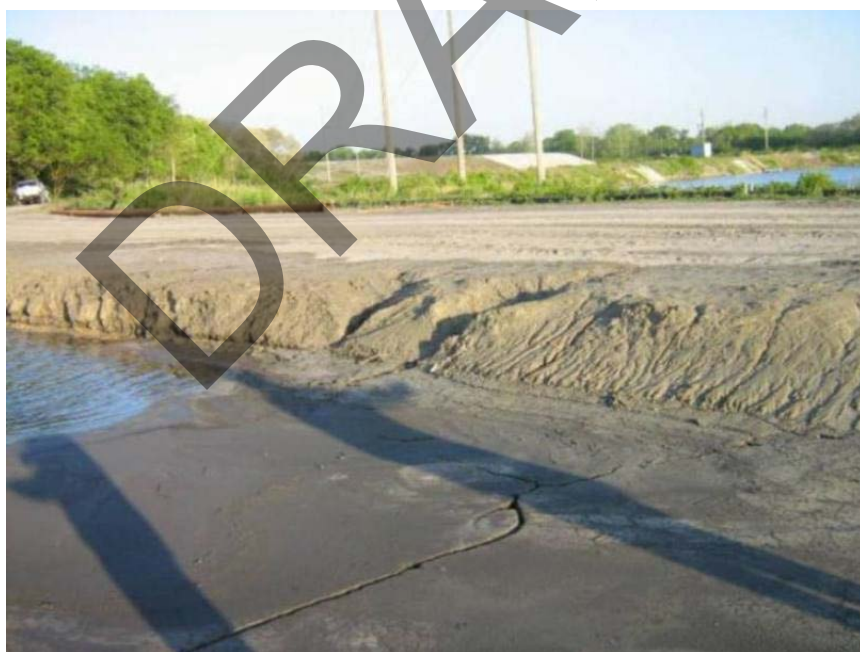
142. Ash Pond 4A - Erosion Rills on North Embankment Interior Slope, Looking Northeast from Pond

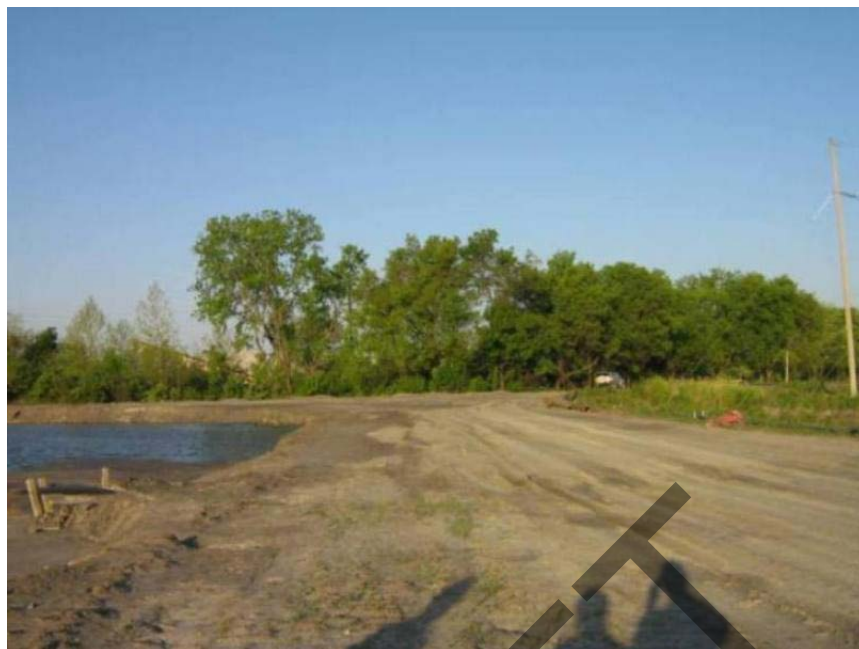
143. Ash Pond 4A - North Embankment Crest, Looking West

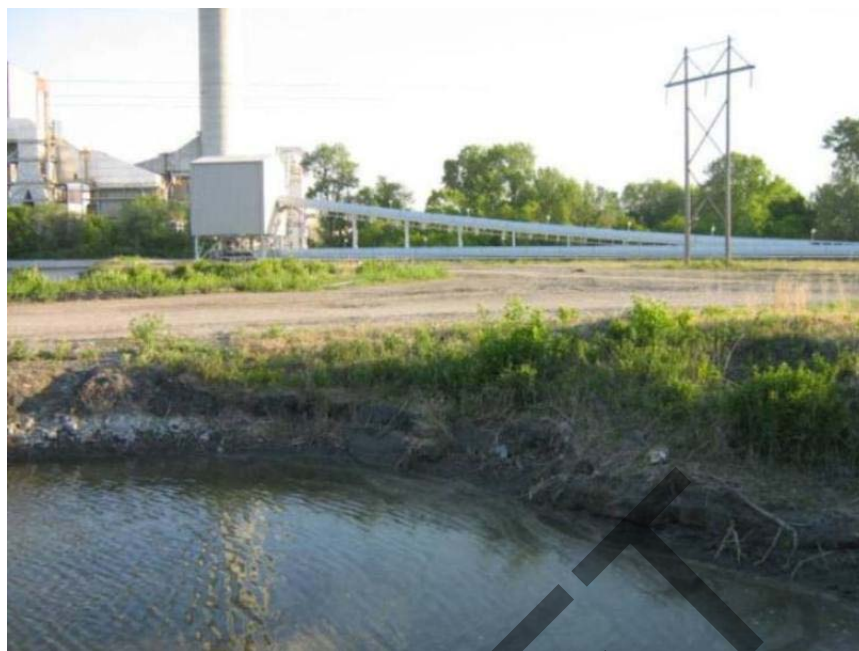
145. Ash Pond 4A - Beaching at Base of East Embankment Interior Slope, Looking North

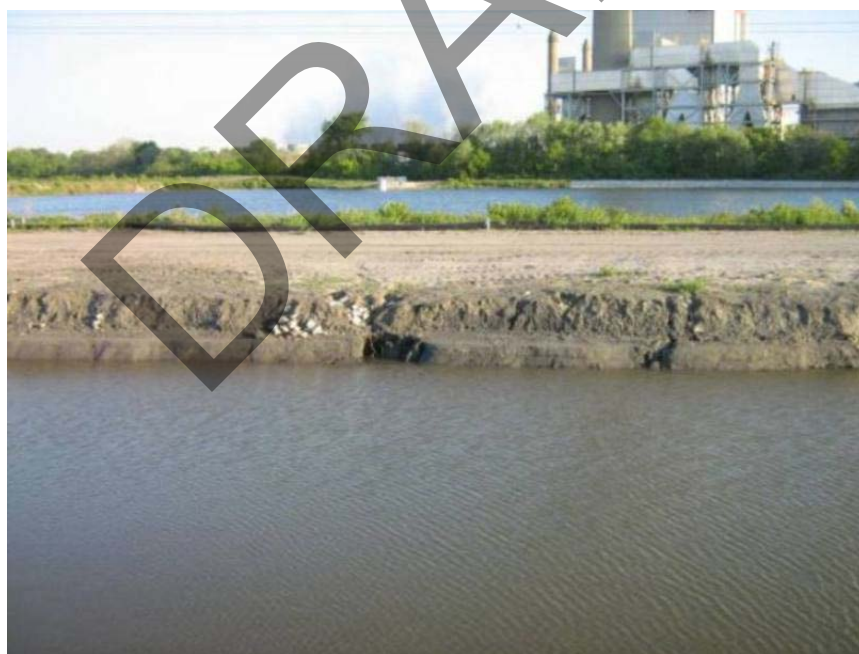
146. Ash Pond 4A - Erosion Rills and Beaching along North Embankment Interior Slope, Looking North

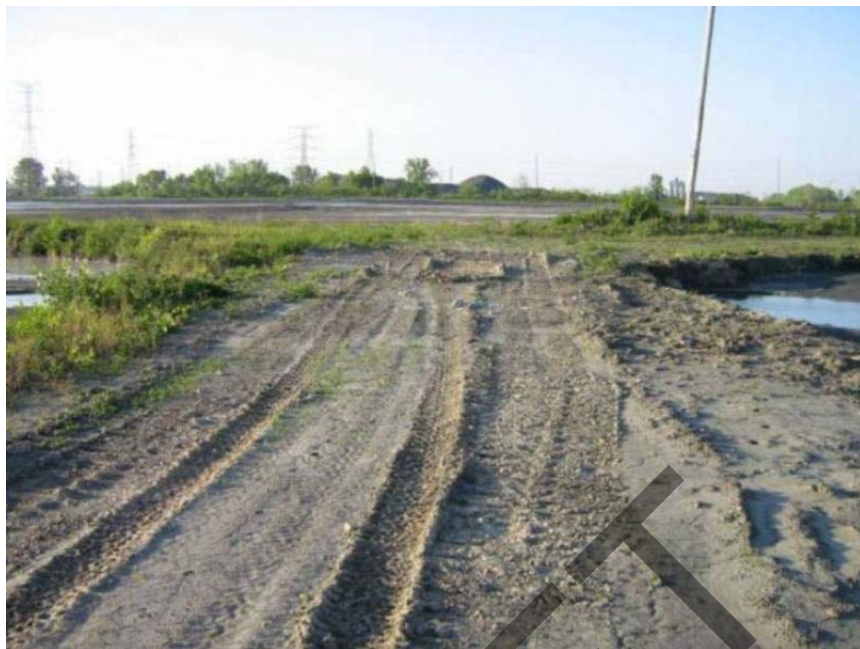
147. Ash Pond 4A - East Embankment Crest, Looking South

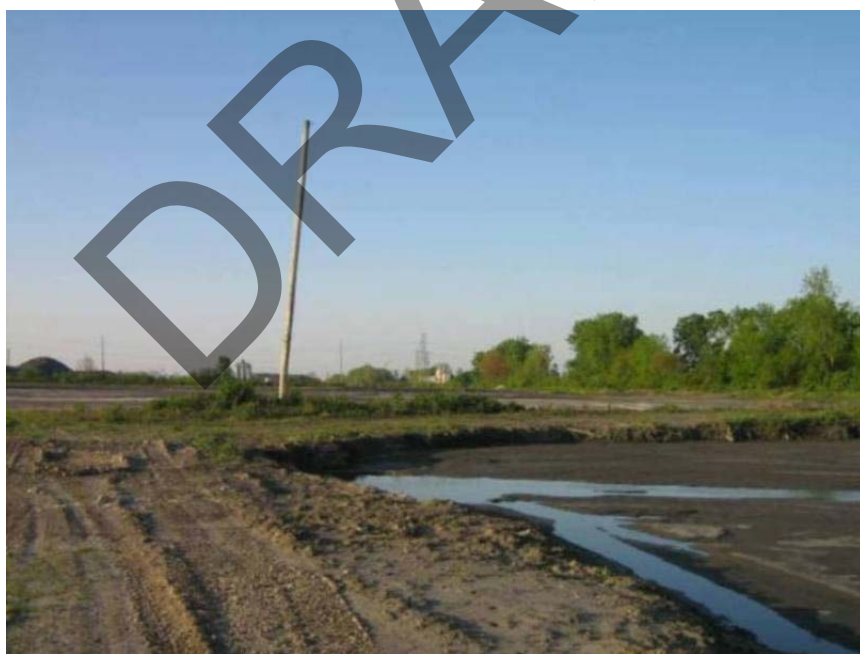
148. Ash Pond 4A - South Embankment Interior Slope, Looking South

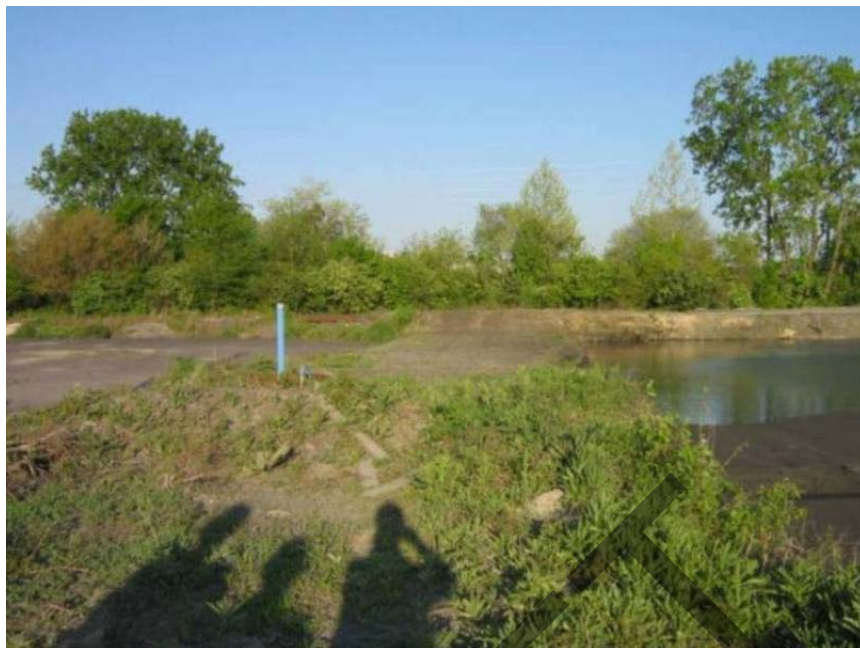
151. Ash Pond 4A - South Embankment Crest, Looking West

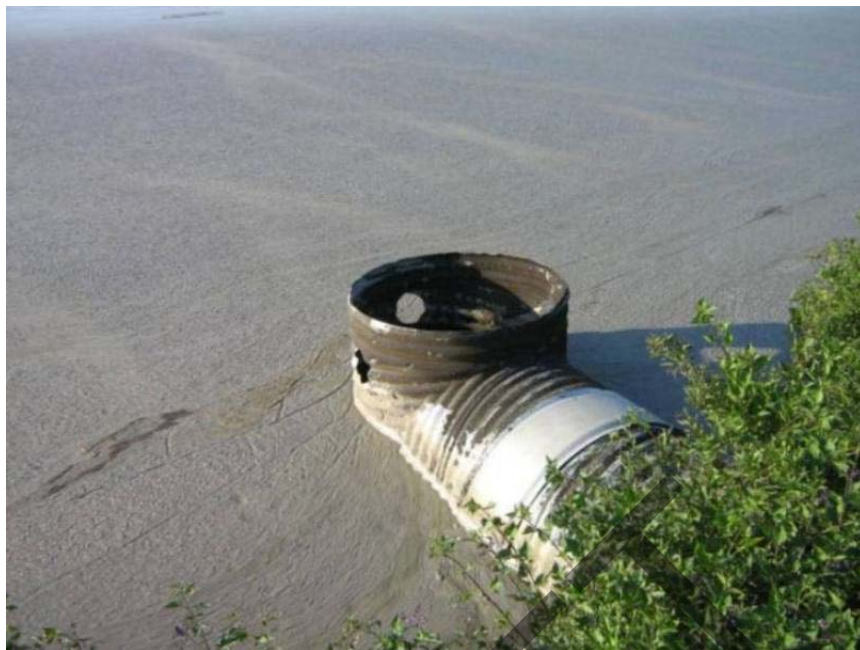
154. Ash Pond 4B - Outlet to Ash Pond 3 Located at Northeastern Corner of Pond

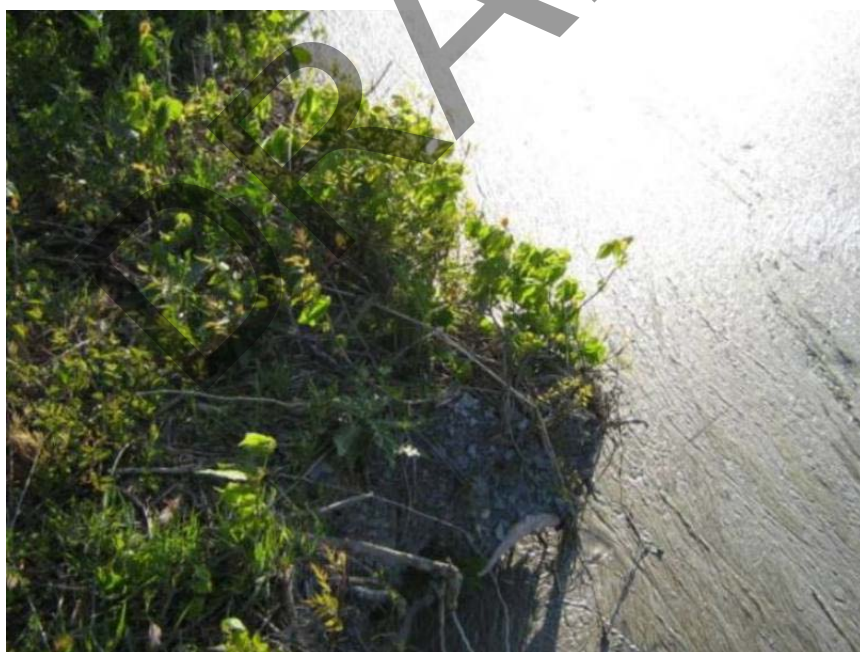
155. Ash Pond 4B - Undercut North Embankment Interior Slope, Looking East

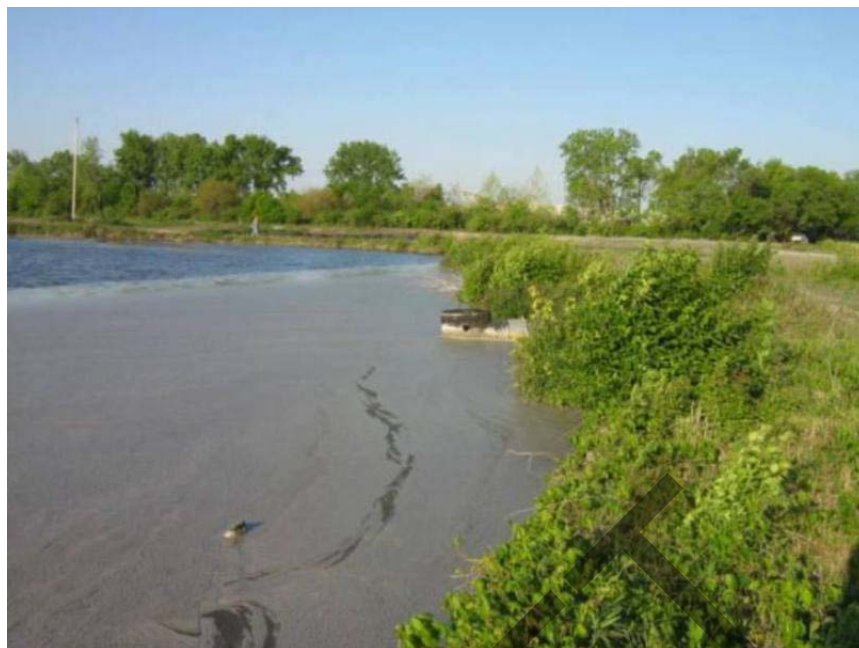
156. Ash Pond 4B - North Embankment Interior Slope, Looking West

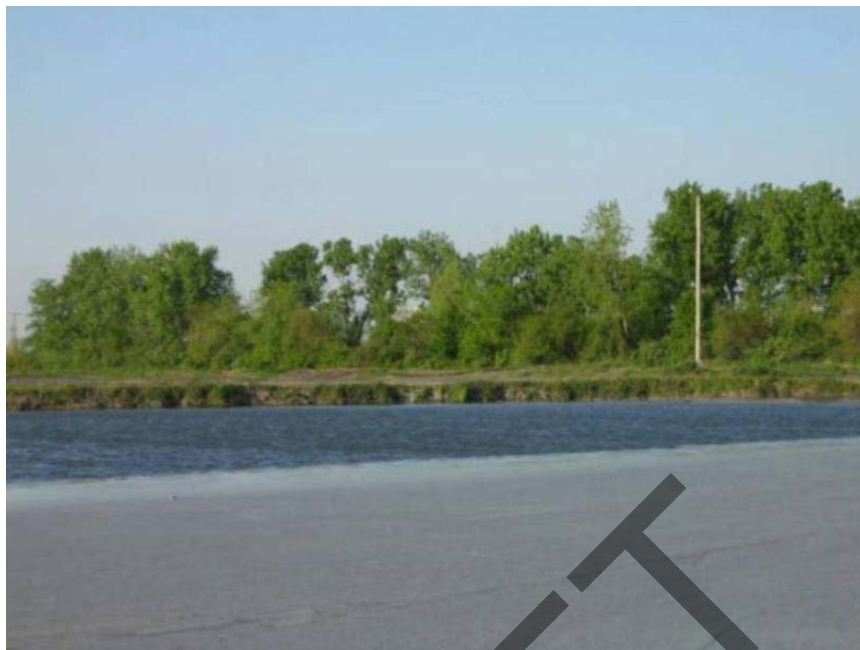
158. Ash Pond 4B - West Embankment Interior Slope, Looking West, Erosion Visible

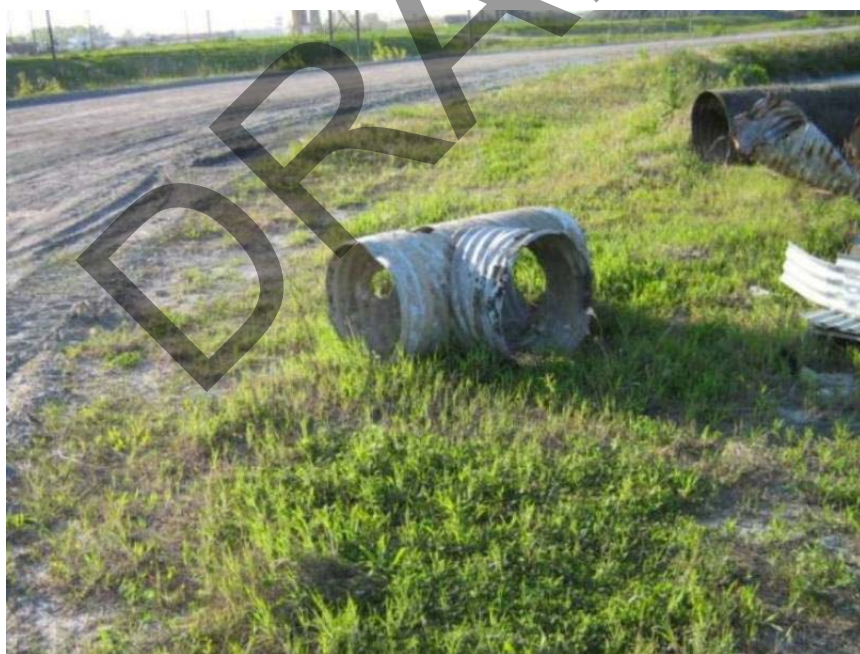
161. Ash Pond 4B - Tee-Joint, Typical of Pond Outlets

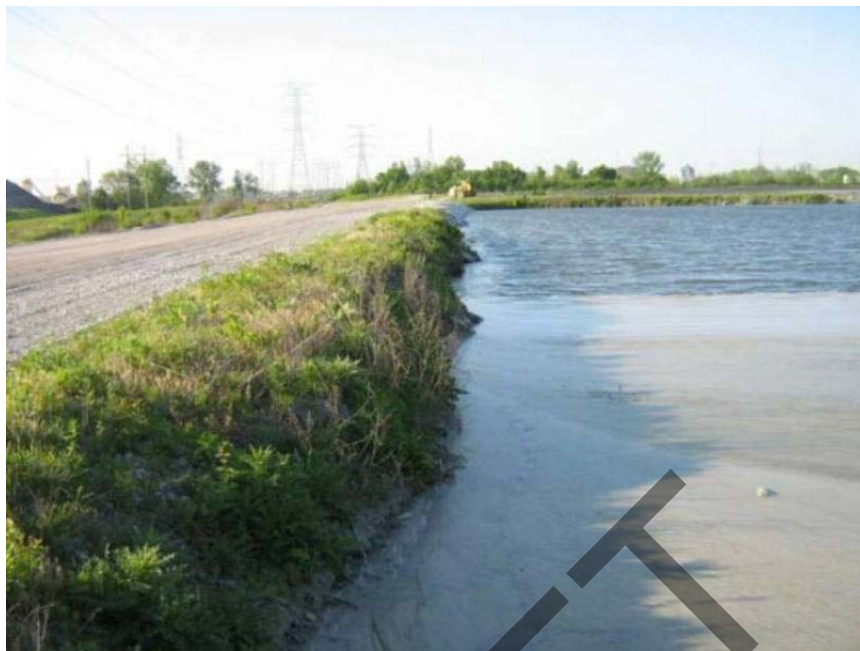
162. Ash Pond 4B - East Embankment Interior Slope, Looking South

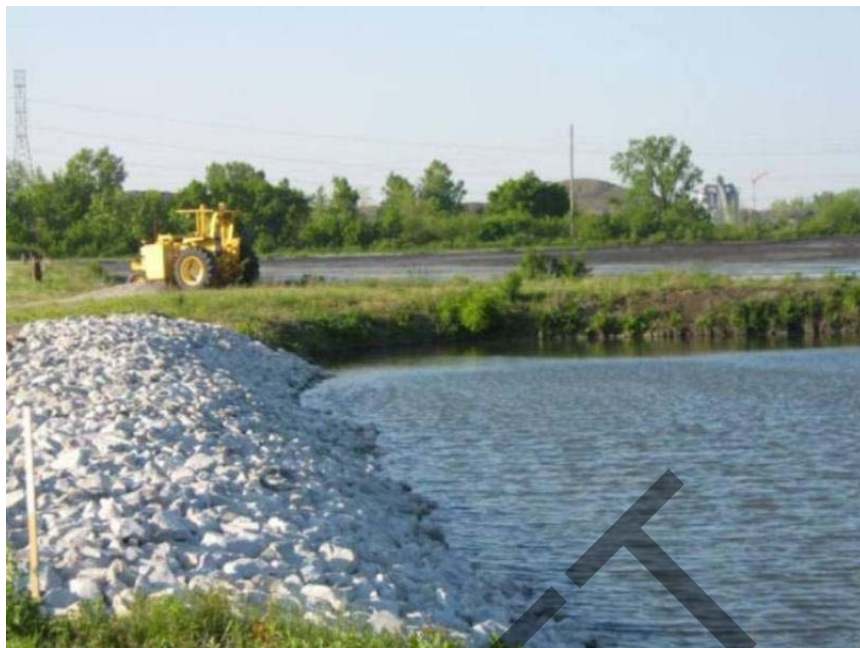
164. Ash Pond 4B - Riprap used to Stabilize Slope along East Embankment Interior Slope, Looking South

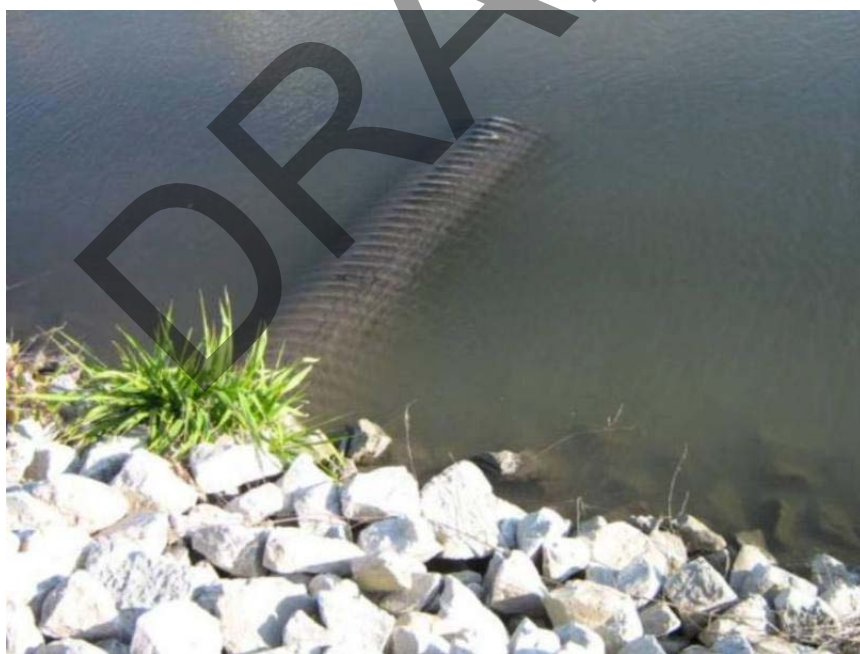
165. Ash Pond 4B - High Inlet from Ash Pond 4, Low Inlet is approximately 5 feet West, Both Inlets are 30-inch-Diameter CMP's
